January 30, 2020

**KSM Project**  
**Comparison of the KSM Tailings Management Facility to Feijão Tailings Dam**

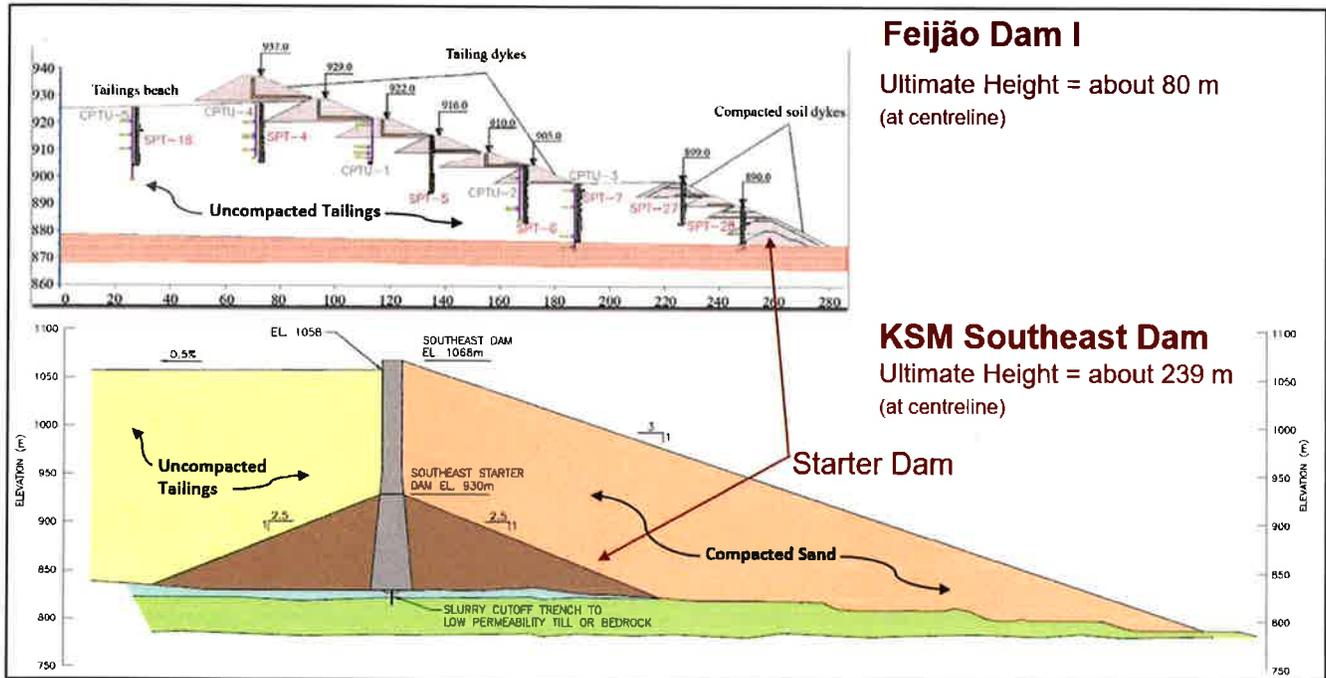
**Figure 1 Comparison of Cross Sections**

The factors that created the conditions for the Feijão failure would not occur for the KSM TMF as further summarized in Table 1. For reference, a comparison of the cross sections is shown in Figure 1.

A setback in the design that pushed the upper portions of the slope over weaker fine tailings	The KSM TMF design does not include a setback (Figure 1), and is not constructed over tailings due to the centerline design. As the dam is raised the compacted shell gets larger and wider to maintain the FoS.
A lack of significant internal drainage that resulted in a persistently high-water level in the dam, particularly in the toe region;	The KSM TMF has a continuous, low permeability till core in the center of the dam that limits seepage through the dam. Underdrains below the downstream sand shell promote drained conditions in this part of the dam that provides stability.
High iron content, resulting in heavy tailings with bonding between particles. This bonding created stiff tailings that were potentially very brittle if triggered to behave undrained.	The KSM tailings does not have a high iron content and is not anticipated to have a brittle behavior. Additionally, as stated above, the integrity of the dam does not rely on the properties of the tailings.
